NRL Memorandum Report 2196

## Damage Analysis of Wire Rope From a 34-Month Ocean Mooring

October 1970

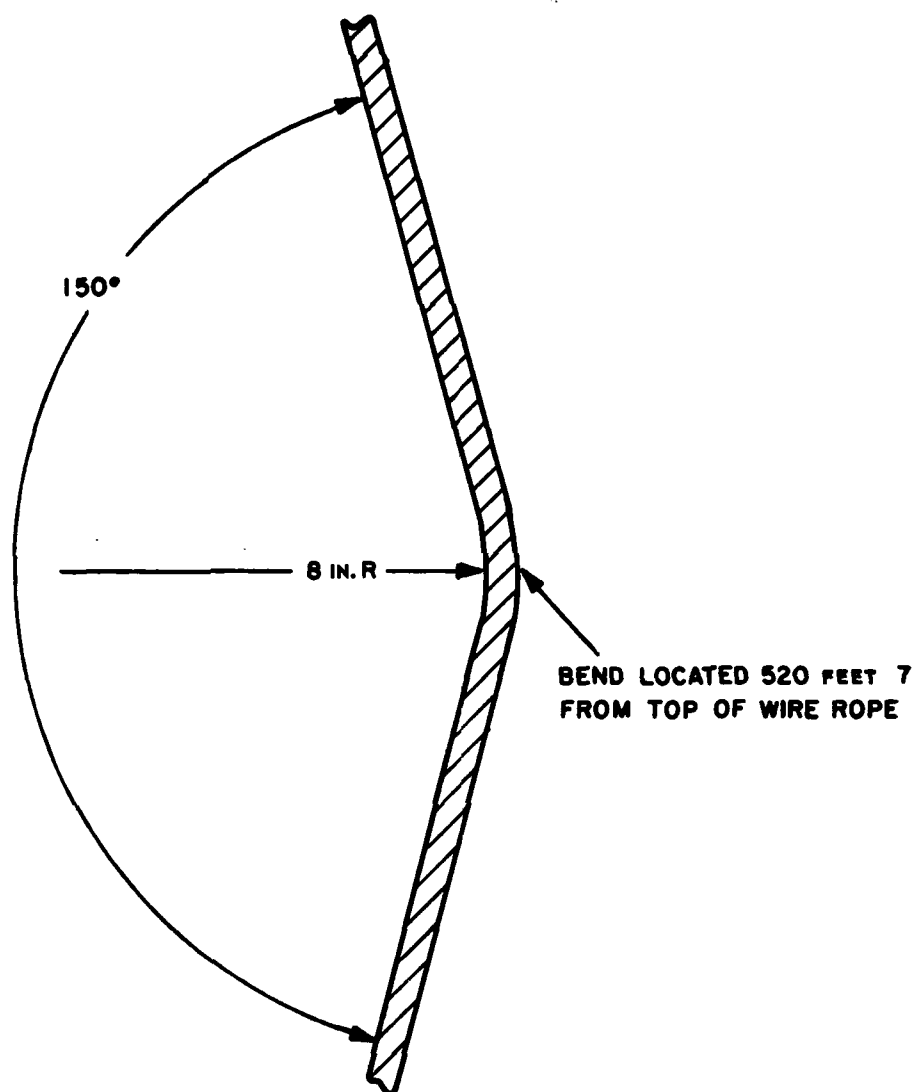
The mechanical condition of specimen 3 (which is not shown in sample 3 of Fig. 2) should be noted. Specimen 3 contained the permanent bend that is illustrated by the sketch in Fig. 3. The bend is shown in its relaxed condition. This permanent deformation showed no wire breaks nor great external disarrangement of strands or strand wires. The bent cable was included in the 30-inch specimen removed for break-strength test. Its presence introduced certain variations in the damage data which will be discussed in a later section of the report.

The events which produce a growth in damage defects after occurrence of a bend deformation seem fairly obvious. When a rope is permanently deformed the strands and wires within the construction are disarranged from their normal lay position. Subsequent cycles of load produce abnormal relative motion and excessive abrasive wear in unfavorably oriented wires. Abrasion removes the protective coating that forms on the surface of stainless steel when it is cathodically protected, and it also scrapes the surface clean of its protective lubricant. The exposed stainless steel provides new corrosion sites and corrosive defects will begin to appear. Corrosion products are added to the lubricant and since these are abrasive they convert the lubricant into (literally) a grinding compound. Thus an initial deformation bend produces an undesirable mechanical motion and resultant mechanical abrasion clears the way for corrosion. From then on these damage mechanisms are mutually supportive and the processes producing degradation are accelerated.

**Fig. 3 - Permanent Bend In 3/4in. Stainless Steel Rope. This permanent deformation (shown in a relaxed condition) initiated internal damage in the wire rope.**

A solution to the jacket and the rope bend-deformation problem are paramount to an extension of service life for the NOMAD System. It has been shown that mechanical mechanisms were responsible for initiation of the degradation processes at damage centers in the wire rope portion of the NOMAD mooring line; that these mechanisms were generated through a mishap either during installation of the system or during its service

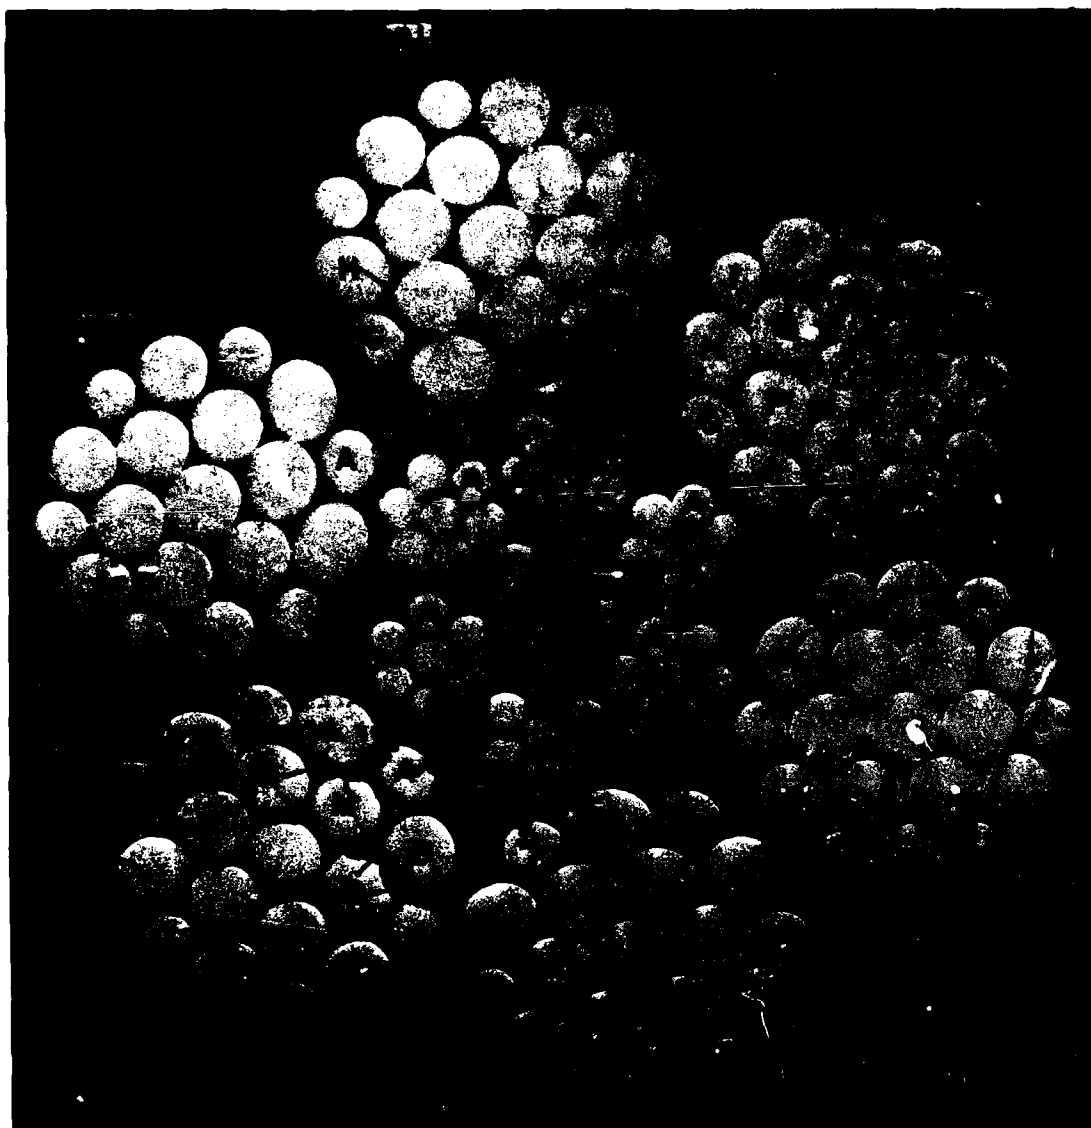
In a similar manner Fig. 4 reveals damage that is indicative of conditions in specimens 5 and 7, and to a much lesser degree in specimen 3. The mechanisms causing these defects are identified and located in Table III. In addition to the defects shown in Table III, clean sharp wire breaks occurred typically at positions 7-1-A, 7-2-G and 7-7-G in Fig. 4; these breaks were observed only in specimens 5 and 7 (see Table I).

<u>Mechanism</u>	<u>Labeling of Examples</u>
a) External Scrape	3 - C
b) Interstrand Wire Mark Due to Adjacent Outerstrand	1 - G
c) Interstrand Wire Mark Due to IWRC	5 - A, 7 - 1 - C, 7 - 4 - A
d) Intrastrand Wire Marks	1 - H, 5 - M, 5 - R, 7 - 1 - E
e) Corrosion Etches	7 - 7 - G, 7 - 7 - C
f) Corrosion Pits	5 - N
g) Corrosion Striations	7 - 3 - G
h) Corrosion Tunnels	Heavy 5 - I, Medium 1 - E, Light 4 - I

**Fig. 4 - Wire And Strand Labels And Identification Of Major Rope Defects.** Strand numbers and wire letters enable the location of defects within the rope construction. Cross-hatched wires within the IWRC identify the predominant location of complete wire breaks. This photograph indicates damage defects typical of those found at distances of 1010 feet and 1227 feet from the buoy end of the rope mooring. The average diameters of undamaged wires were as follows:

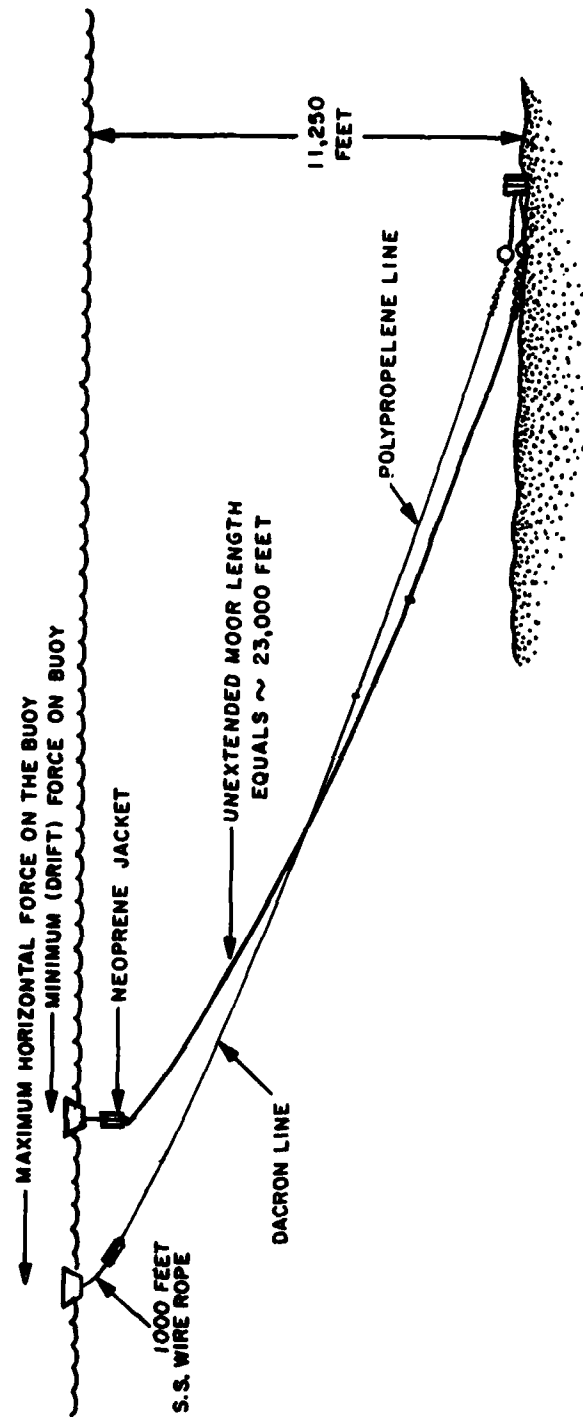
The sketches in Fig. 9 approximate the geometric shapes of the composite mooring line for two boundary load conditions on the buoy. For the first condition, a minimum horizontal force is applied to the buoy. The wire rope (approximately 1000 feet) hangs in a near vertical position and joins the dacron portion of the moor at a junction angle somewhat larger than 120 degrees. The dacron and polypropylene portions of the moor extend downward at an angle that approaches  $30^{\circ}$ . The stainless steel chains and ballast ball lie on the sea bed. For the second boundary condition, a maximum horizontal force is applied to the buoy. The wire rope rotates to assume a more in-line position with the remainder of the moor. There is relatively smaller change in the angular position of the synthetic portions of the line, but an increased length because of added tension. The stainless steel chains and ballast ball may lift off the sea bed. Thus energy added from the buoy forces is absorbed within the mooring system through an angular deflection of the wire rope, an extension of the mooring line components and a lifting of the chain and ballast ball. Maximum extensions occur in the highly elastic synthetic portions of the mooring. The system is highly damped with respect to dynamic excitation of the buoy.

The scrape marks are indicative of but one mode of the jacket - rope motional environment which in its totality precipitated damage in the rope. As stated in the previous discussion on forces and motions in the NOMAD system, inflection points in the curvature of the composite mooring line will occur at the junction of dissimilar line components and at the upper end of the neoprene jacket. Thus inflection points existed at both ends of the jacketed portion of the rope and under changing load conditions transverse motions of the line also developed at these points. As previously noted any action which cleaned the surface of the stainless steel of its protective coating and of its lubricant would initiate corrosion damage sites and promote a mutually supportive chain of degrading events. The listing of damage defects in Table I for these two damage centers (locations 5 and 7) is proof positive of the potency of this mechanical effect.

Fig. 9 - Forces And Motions In The General NOMAD System. The relative position of mooring components is shown for a maximum and a minimum horizontal force on the buoy. The sketch is also applicable to the particular NOMAD system under study.
